# Manhole Inspection Summary

Manhole # S21AA1002MH

Insp Date: **1/30/07 2:21 PM**

**Location** Address: **3422 SENECA ST**

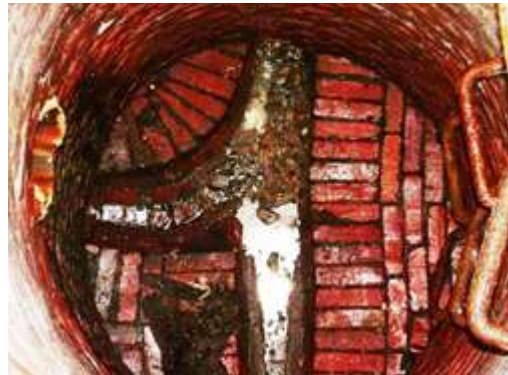
Top View

Corbel and Barrel infiltration. Corroded steps. Bench and Channel debris.

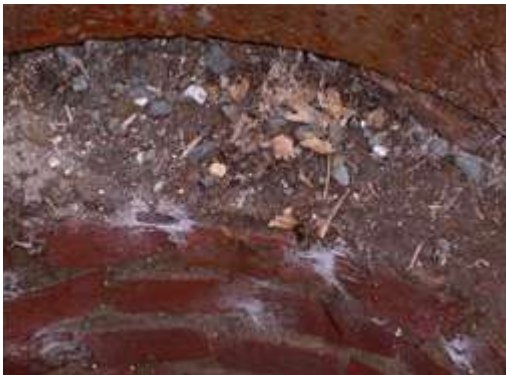
Defect

Frame leaks. Frame offset. Adjustment deterioration and infiltration.

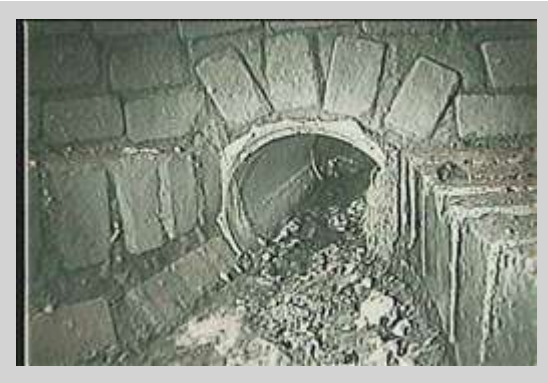
### 8 in. Circular Gravity Sewer Pipe Out @ 12 O'Clock

Barrel deterioration, root intrusion and infiltration. Channel deterioration.

Infiltration: **Evidence** Pipe Seal Cond: **Roots**

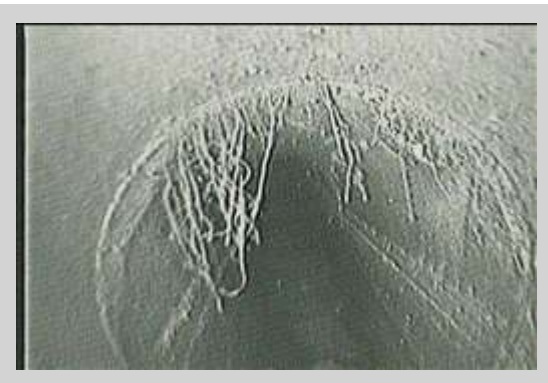
### 8 in. Circular Gravity Sewer Pipe In @ 6 O'Clock

Infiltration: **Evidence** Pipe Seal Cond: **Roots**

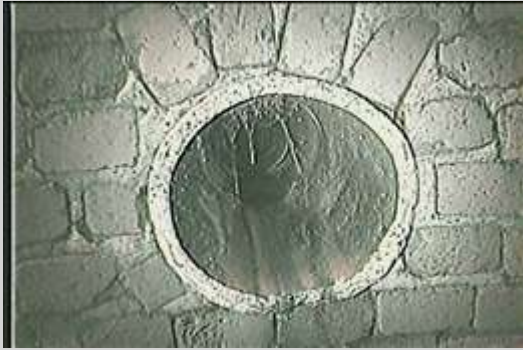
Pipe In @ 9 O'Clock

Infiltration: **Evidence**

Pipe Seal Cond: **Roots**
